## Service Focus

Solving the Problem with a Hydraulic Splitting and Bursting System.

**Client:** Incitec Pivot

**Location:** Incitec Pivot, North Geelong

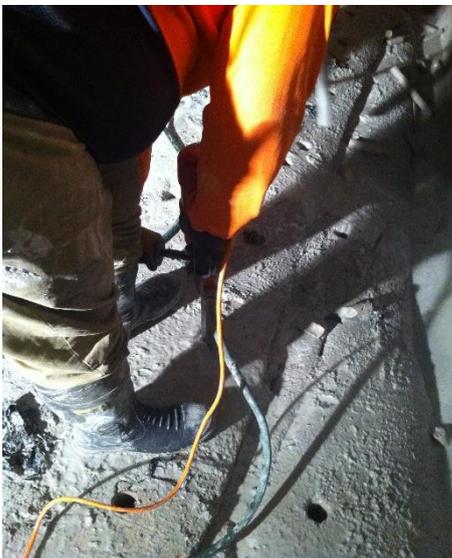
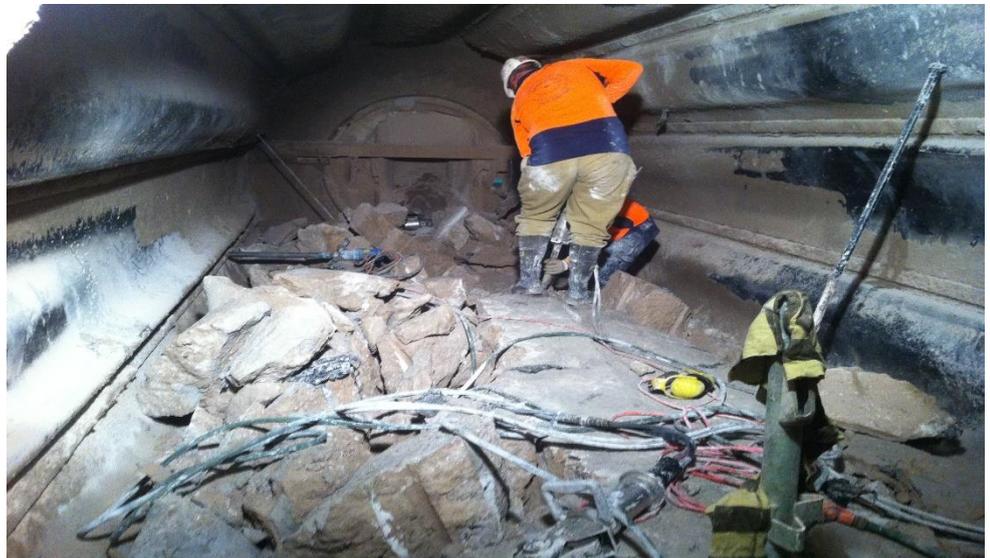
Access into the dryer vessel is limited to a single entry inspection door 700mm wide x 1600mm high. Breaking the hardened material into large chunks for manual removal

breaking up the material The majority of the mass section of material had been cracked through the expandable grout process. This

There was not enough room in the confined space to operate our equipment safely and extract the material at the same time. work shifts were required to remove the material safely
